## North Coast Regional Water Quality Control Board

# Inspection Report for May 29, 2019, Consent Inspection of Trinity County Assessor's parcel number (APN) 016-200-17-00

APN: 016-200-17-00

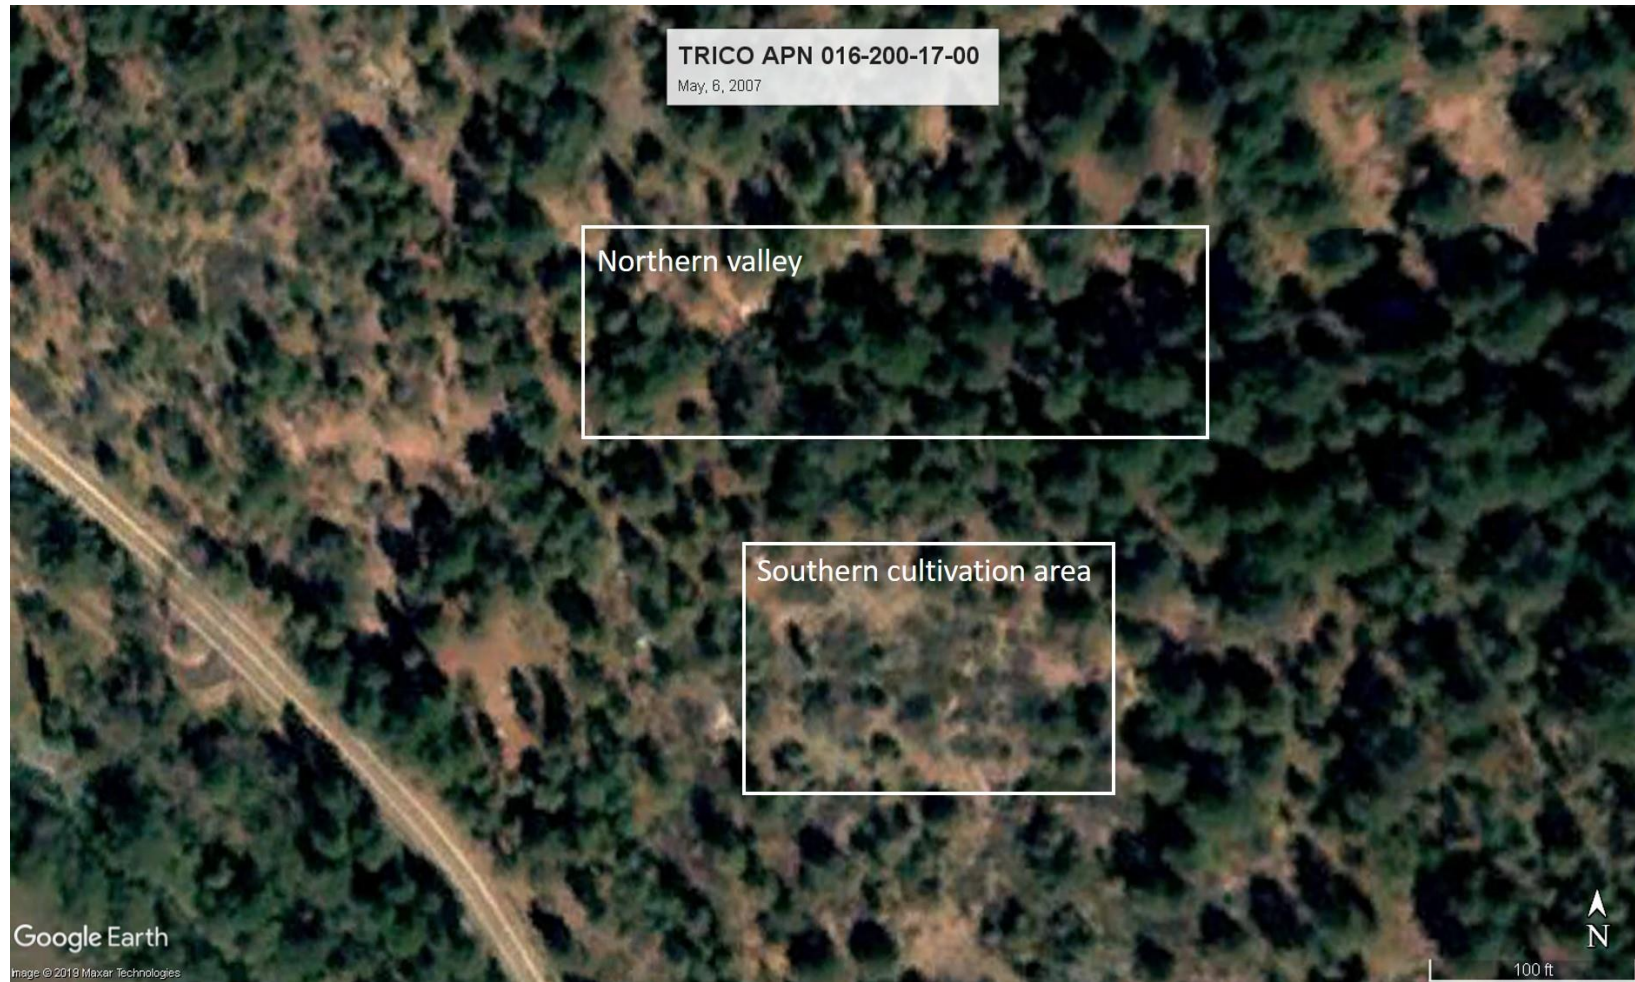
aerial image 1 – shows the property prior to being developed for cannabis cultivation.

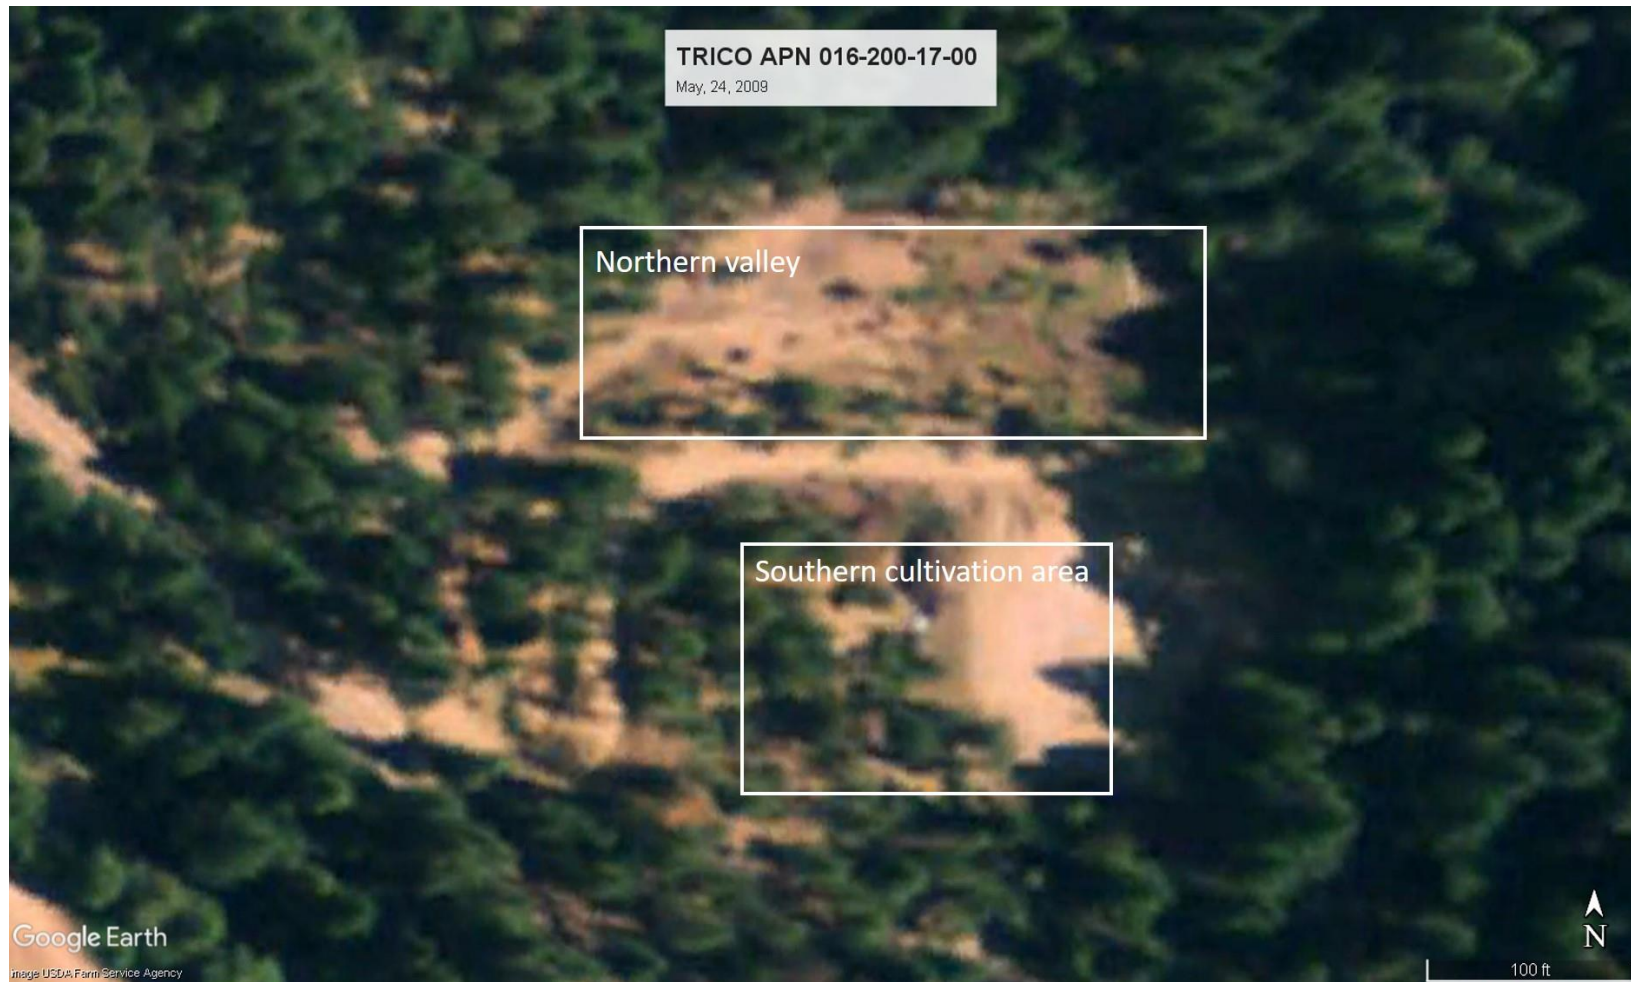
aerial image 2 – Same extent as aerial image 1 showing timber clearing and grading had occurred on the property.

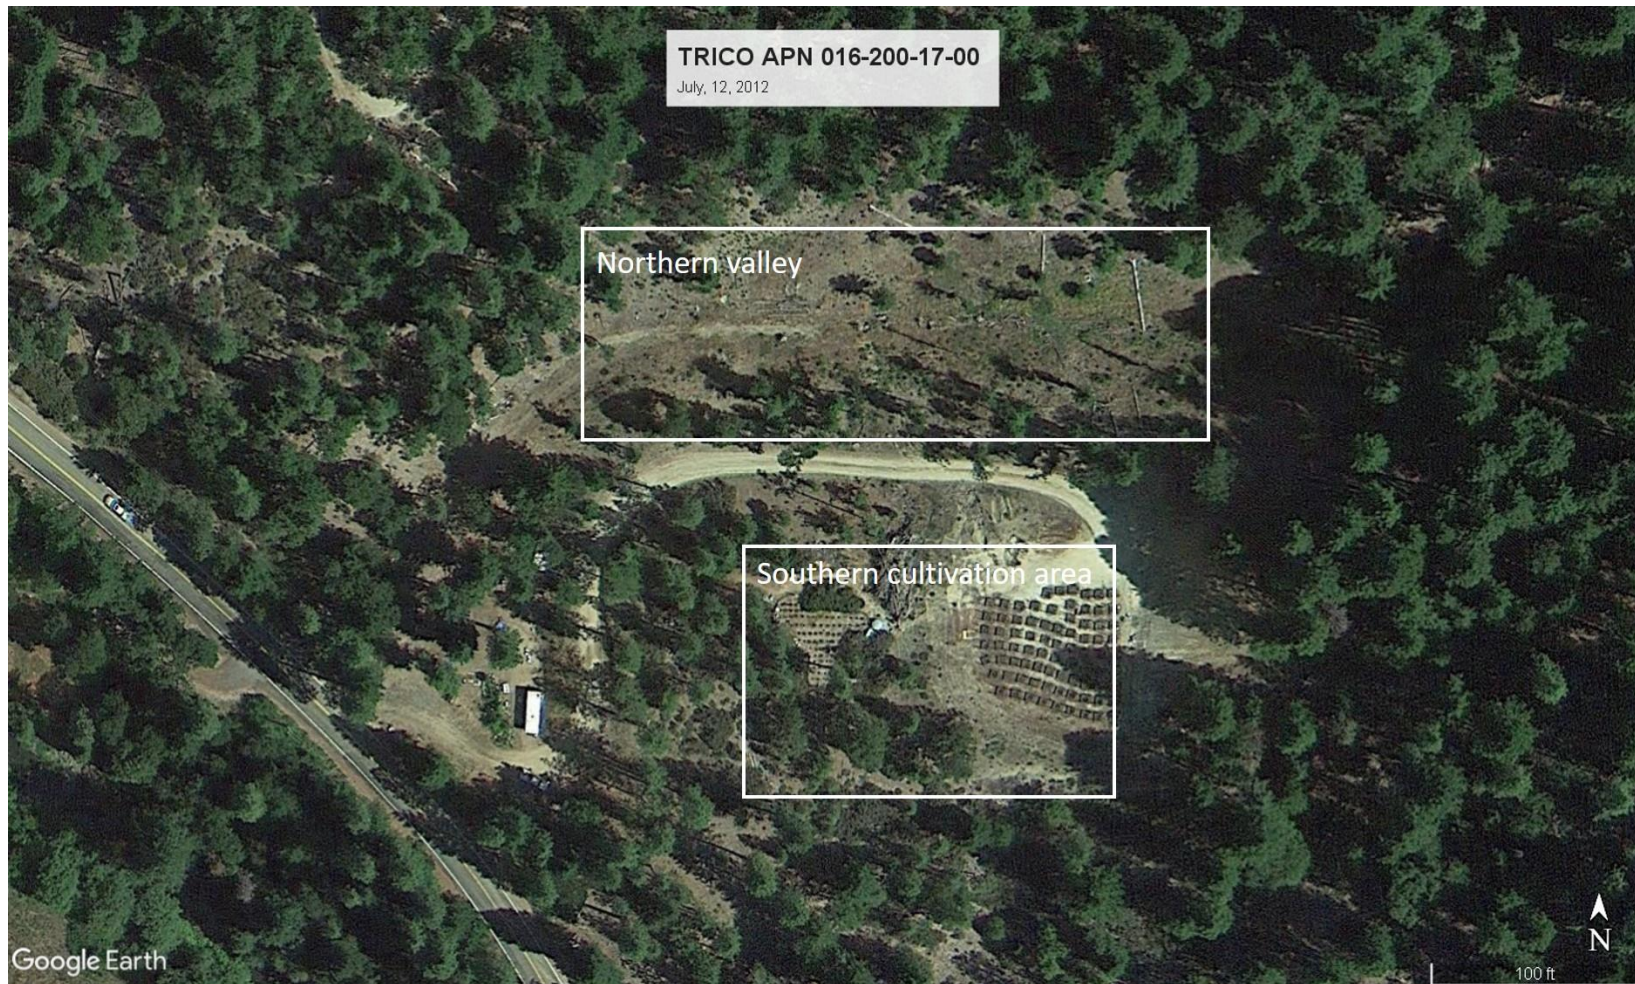
aerial image 3 –Cannabis cultivation at the southern flats had been occurring since at least July 12, 2012.

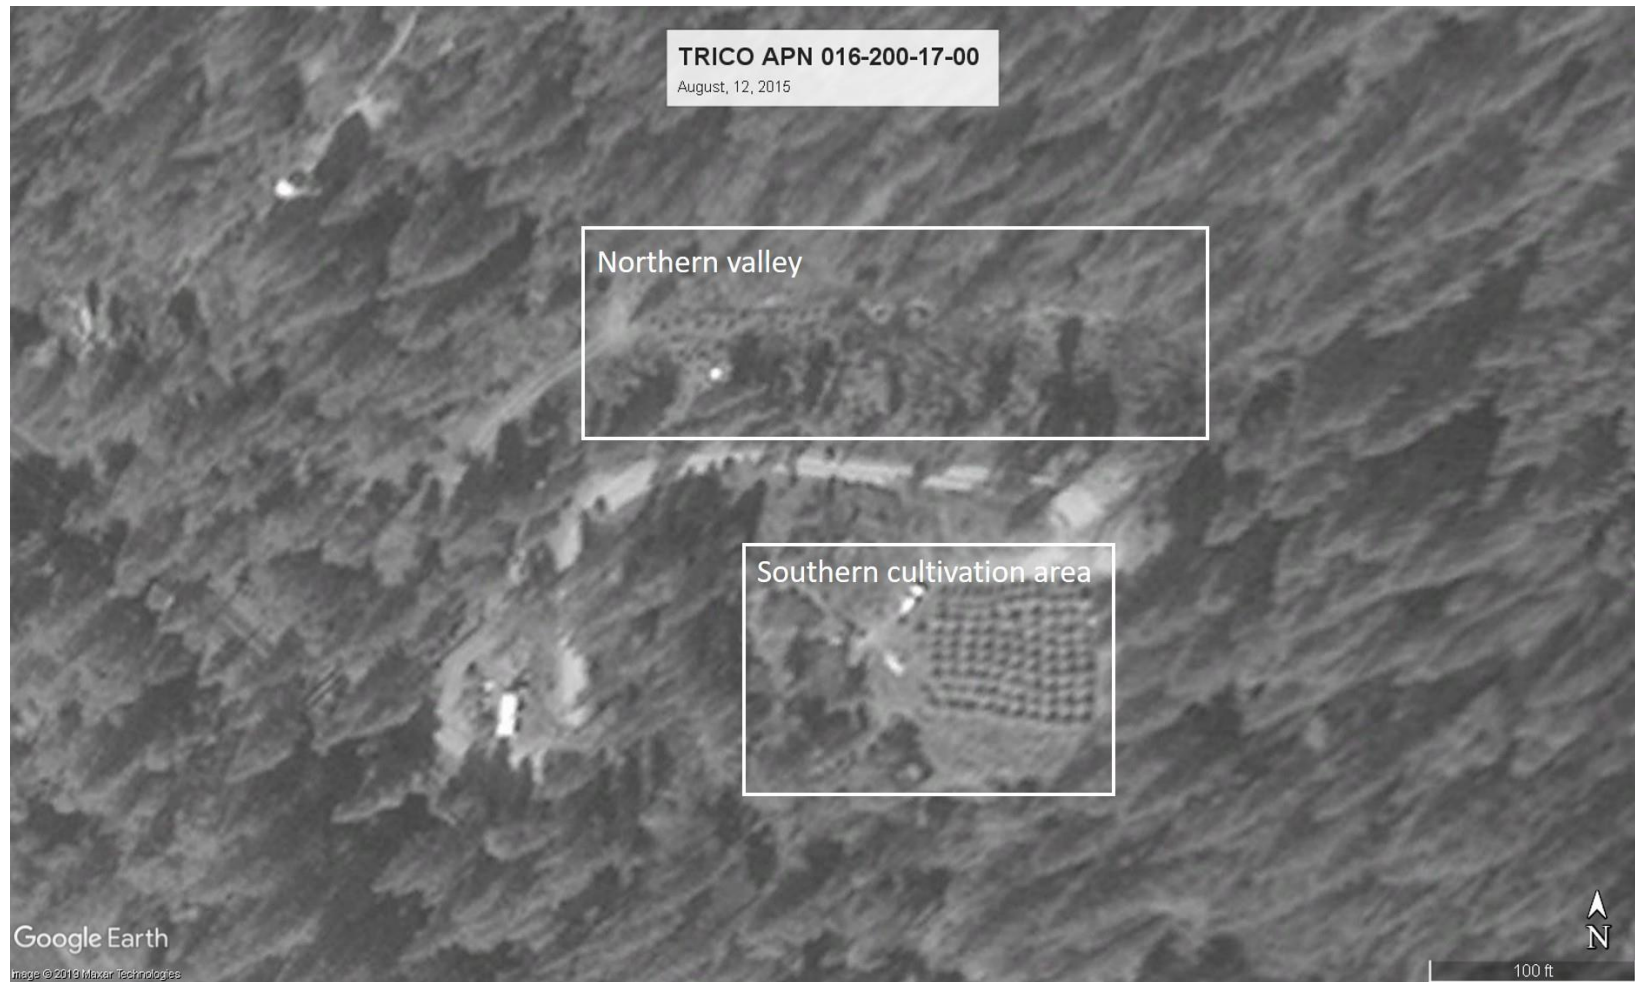
aerial image 4 – Regularly spaced circles apparent in the northern valley suggest cannabis cultivation was occurring in this area.

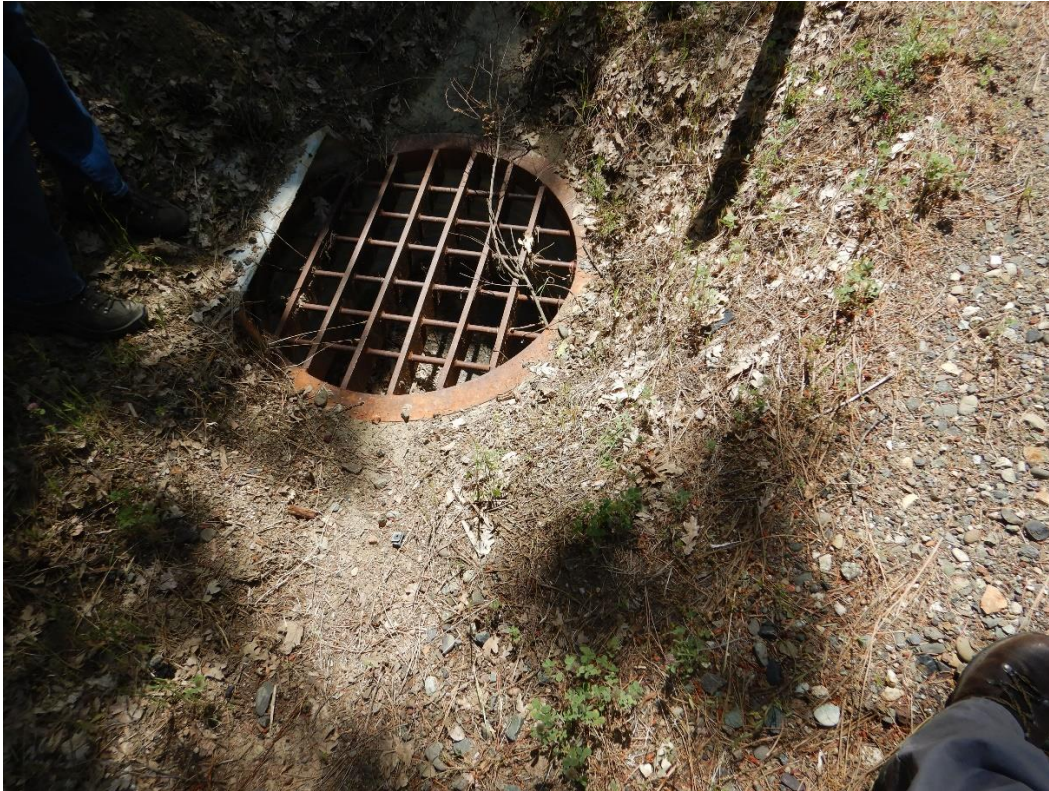
Staff met with inspection participants at the property and walked to the drain carrying water below highway 3 located at WQ 1, (photo 1). Much of the evidence of imported potting soils reported in the CDFW May 14, 2019 NOV had faded; however, perlite was still visible in the roadside ditch a short distance upstream (photo 2) and continued onto the property. We proceeded to the well at WQ 2 (photo 3), which still did not have a sanitary seal. In the vicinity of the well, I observed lenticular lobes of fine sediment with perlite on the valley floor (photo 5). We observed a car (WQ 3) (photo 5) which had been in the watercourse since the July 19, 2018, inspection.

photo 1 – Drain carrying water below highway 3. Some deposited fine sediment is apparent at entrance to drain.

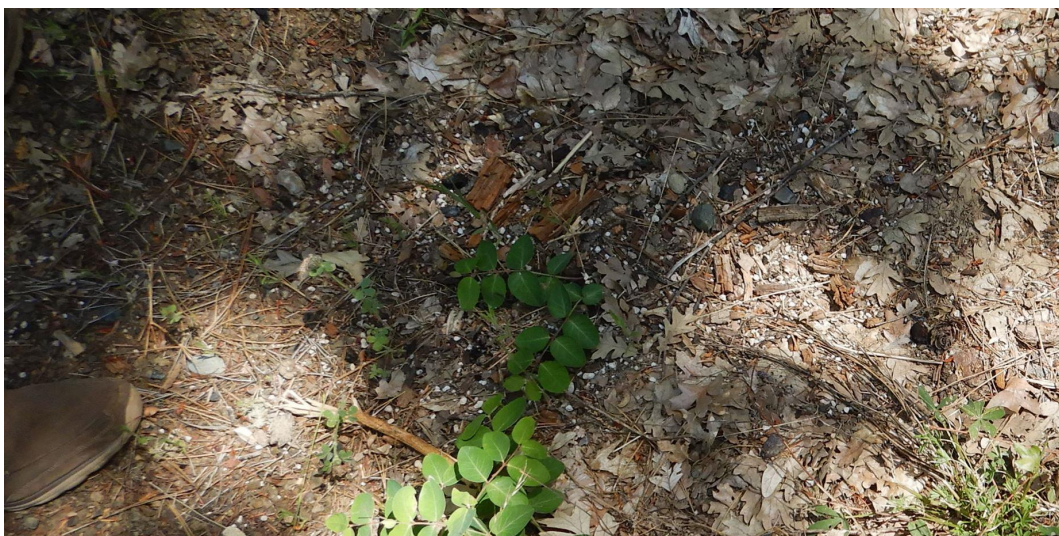
photo 2 – A short distance southeast of the drain pictured in photo 1, perlite is present in the roadside ditch.

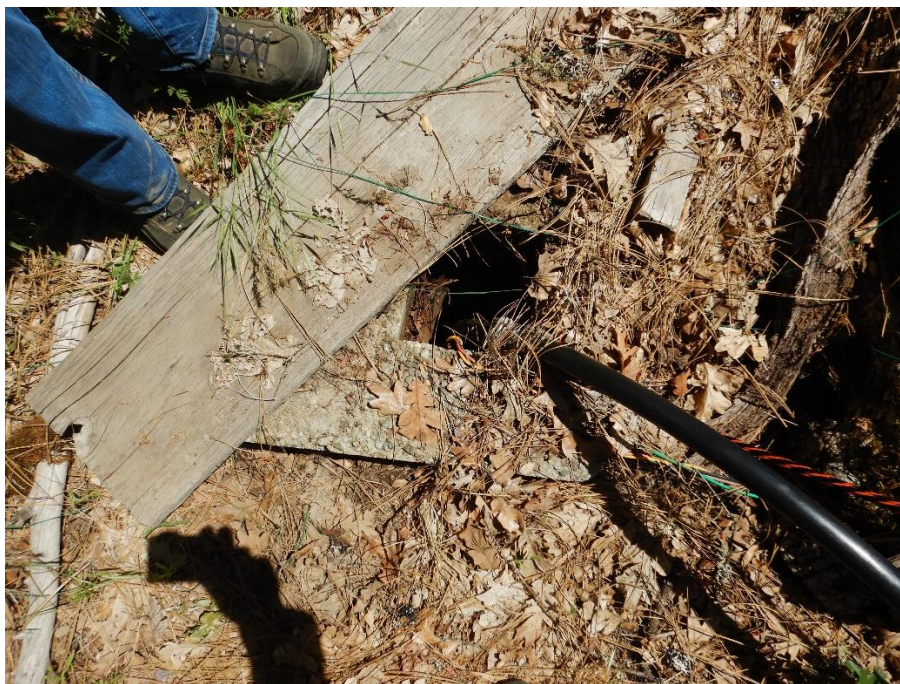
photo 3 – Well covered with wood instead of a proper sanitary seal.

1. Immediately, have a qualified professional install a sanitary seal on the well located at WQ 2 to prevent groundwater from being polluted.
2. Immediately, move the car at WQ3 to a location away from the watercourse.

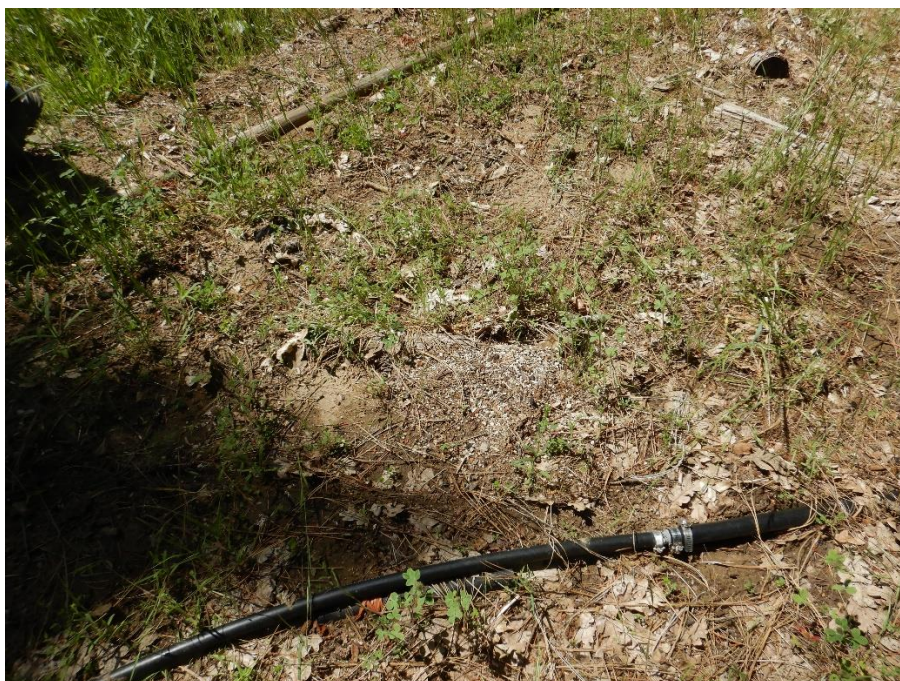
photo 4 – Potting soils deposited in valley.

4. Immediately, retain a qualified professional to develop a plan for removing the remaining cultivation-related waste, including imported potting soils, from the watercourse between WQ 2 and WQ 4 before October 15, 2019.

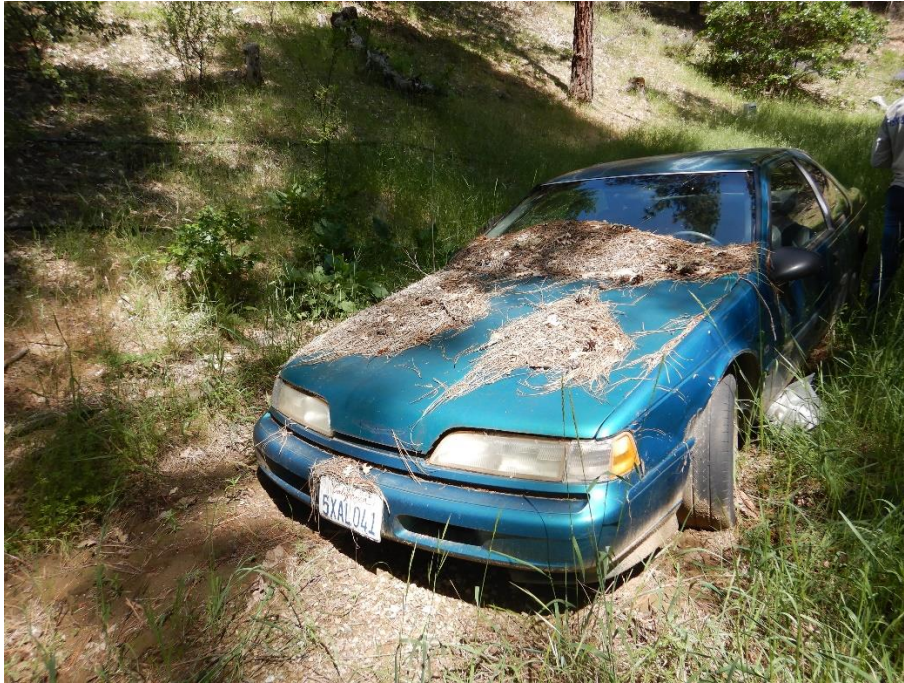
photo 5 – Car being stored in watercourse.

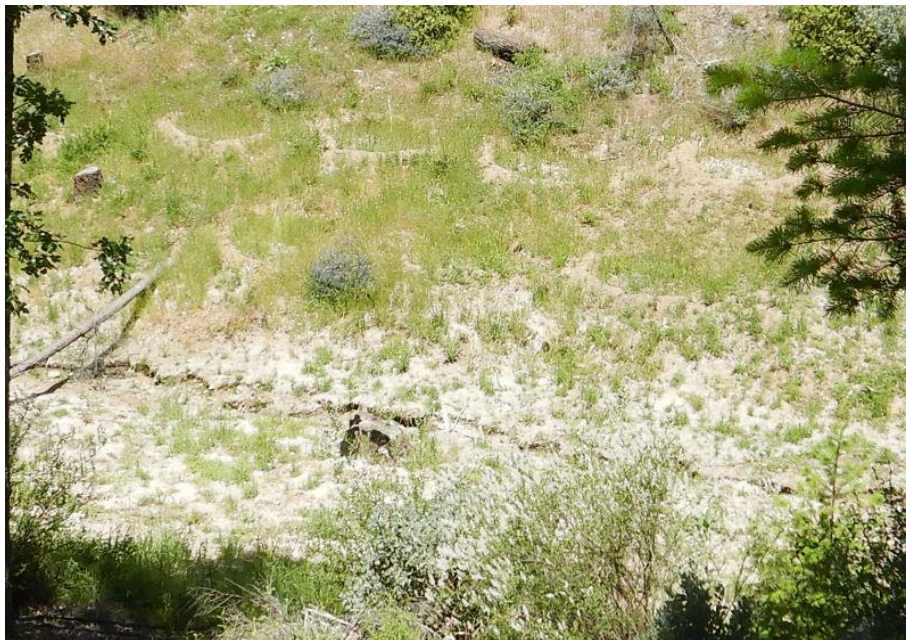
A short distance northeast of (WQ 3) the Valley trends more east-west. I observed much of the straw cover and potting soils had migrated from the valley walls towards the valley bottom (photo 6). A channel (photos 7 - 8), eight inches deep and one foot wide had incised along a 300-foot length of the valley thalweg, creating a void of approximately 200 cubic feet. I observed perlite and cannabis cultivation waste in the incised channel walls at a depth of 8 inches (photos 9 -11), suggesting that either the work performed prior to the wet-weather period or subsequent rain events had moved the waste into the valley bottom and later rain events mobilized the waste, transporting it downstream.

photo 6 – Looking north across the valley. Note the u-shaped features towards the top of the image showing what is left of some of the cultivation beds. Also note the light-colored straw in the lower part of the image where the waste and ground cover had collected.

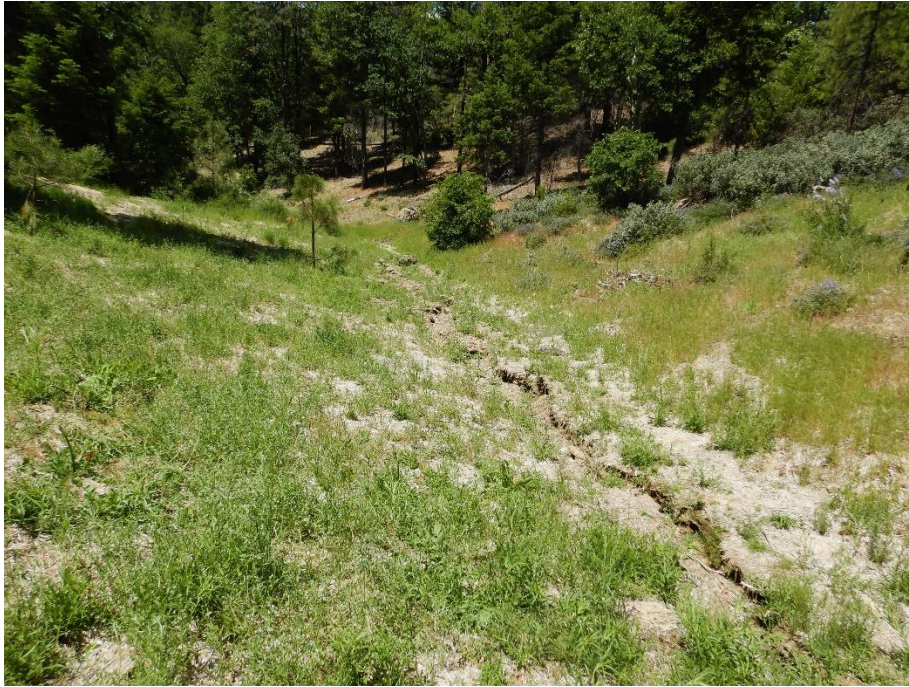
photo 7 – Looking downstream. Note the bottom ten-foot-width of the valley is covered with straw. Bottom one-foot width has an eight-inch deep incised channel.

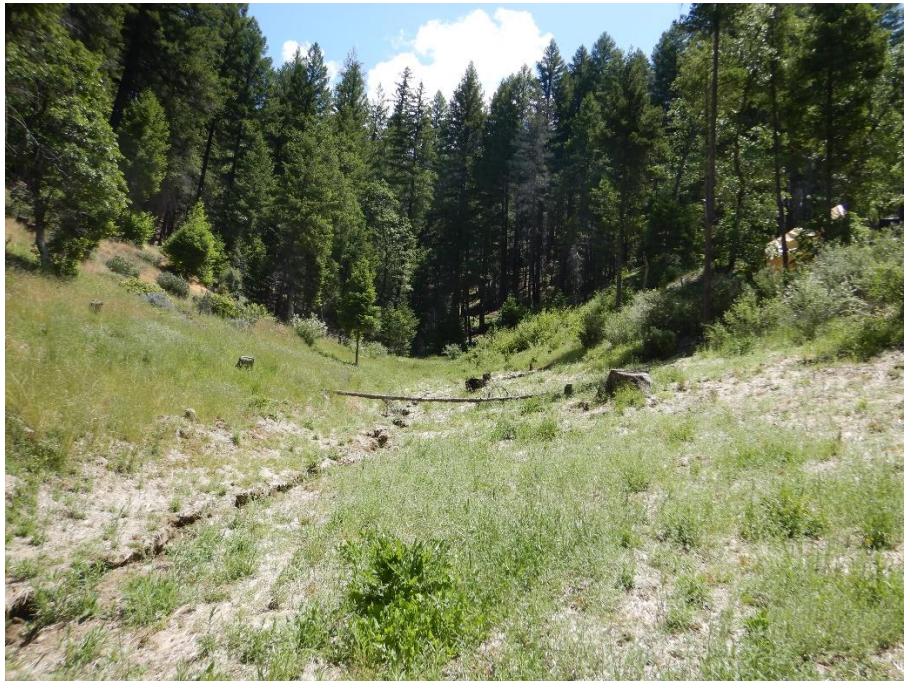
photo 8 – Looking upstream. Note the incised channel extending from the center of the image to the lower right corner.

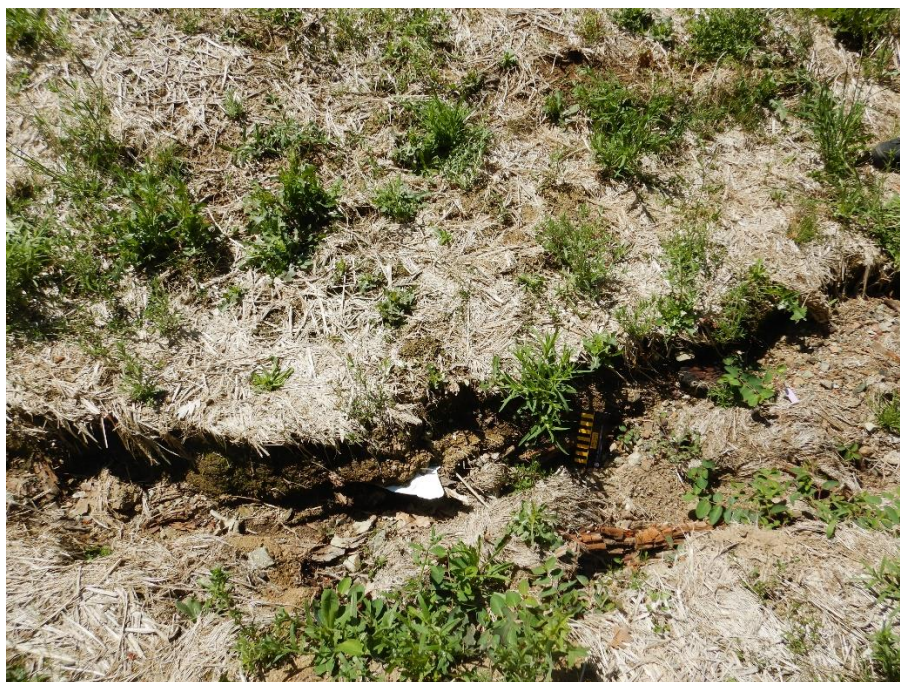
photo 9 –Watercourse incised into deposited potting soils, cultivation waste and other trash. Note scale that shows the trench is about 20cm deep.

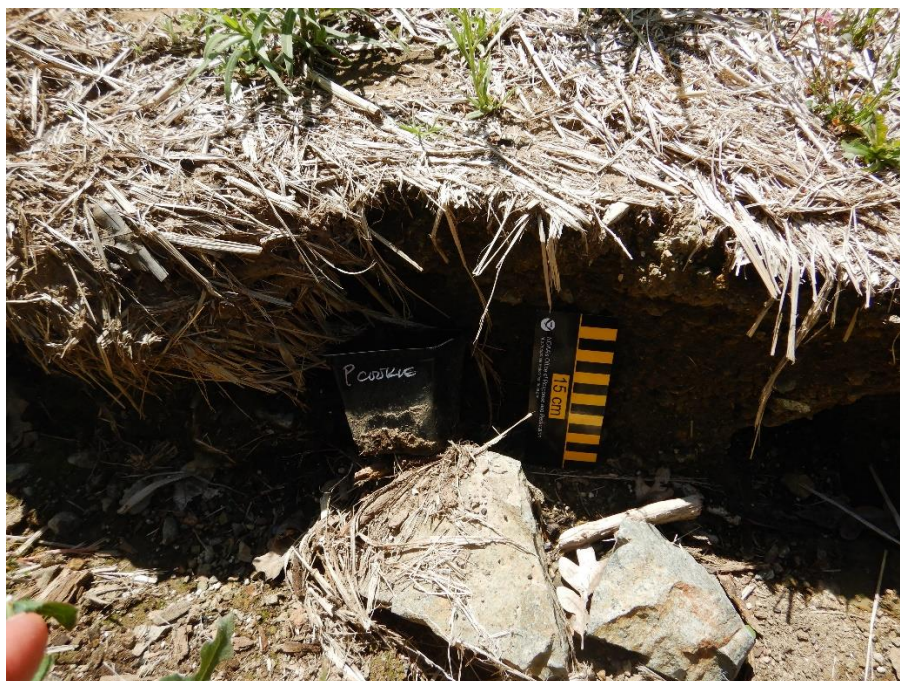
photo 10 – Watercourse incised into deposited potting soils, cultivation waste and other trash. Note pot labeled with the cannabis plant variety "P cookie."

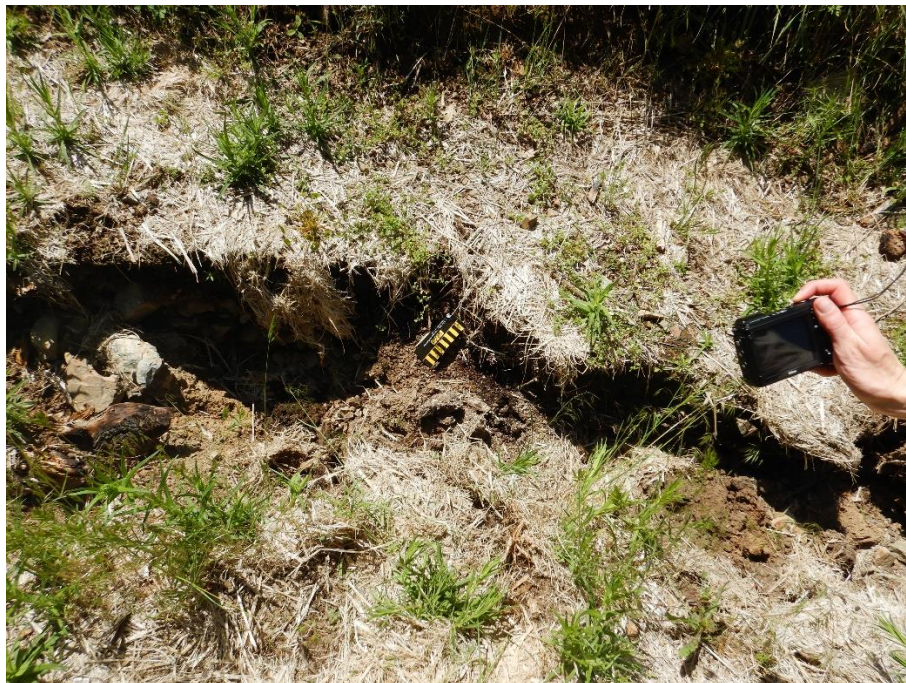
photo 11 – Watercourse incised into deposited potting soils, cultivation waste and other trash.

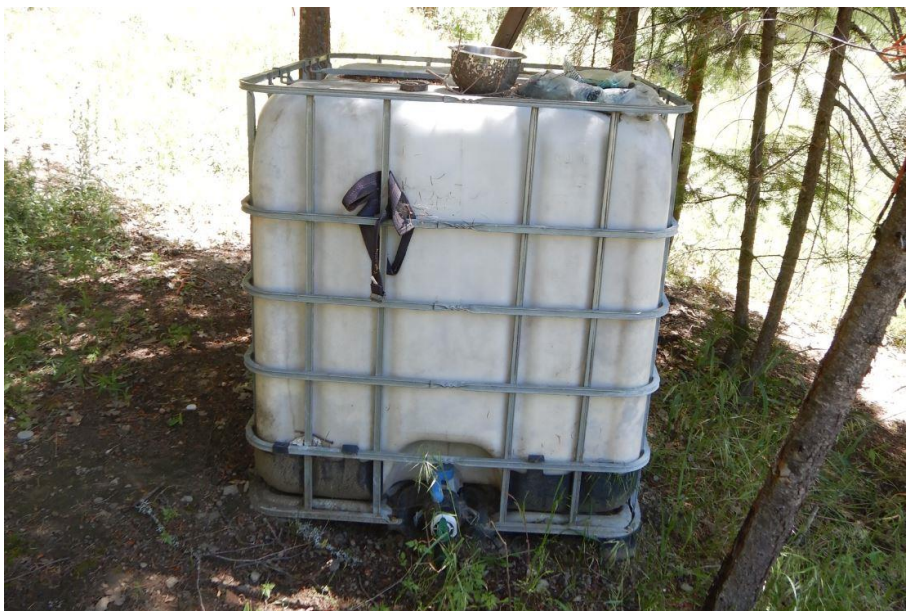
Staff walked upstream to a point there were no more visible imported potting soils, WQ4, and observed a sediment mixing tank with high concentration nutrients sitting on the ground nearby (photos 12 - 13). Staff then walked south to the southern cultivation area and observed rilling on the road WQ 5 (photo 14). In response to questioning about how much potting soil had been cleaned up, Rodney Baker directed me to the onsite location where the potting soils had been taken, WQ 6 (photos 15 - 16). I estimate that a pile no larger than ten feet long, five feet wide and two feet deep, with a maximum volume of 100 cubic feet had been collected. 2016 NAIP Aerial imagery presented in Regional Water Board's July 2018 inspection reports shows at least 100 planter boxes, averaging approximately 4 feet square and one foot deep suggests a volume of at least 1,000 cubic feet of imported potting soils in the valley.

photo 12 – Fertilizer mixing tank, located about 50 feet north of WQ 4.

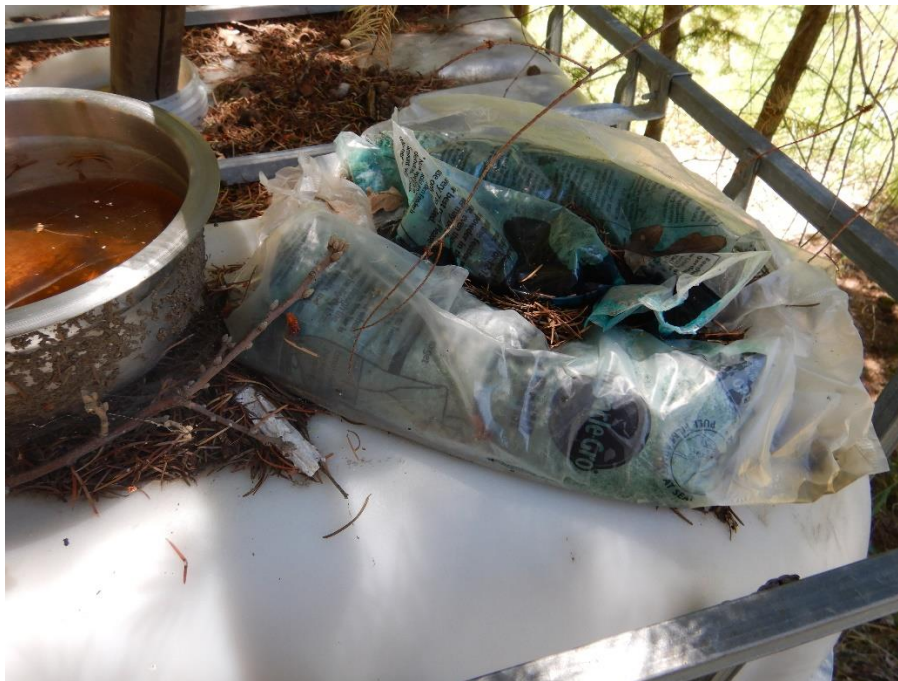
photo 13 – High-concentration potting soils stored on top of fertilizer mixing tank pictured in photo 12.

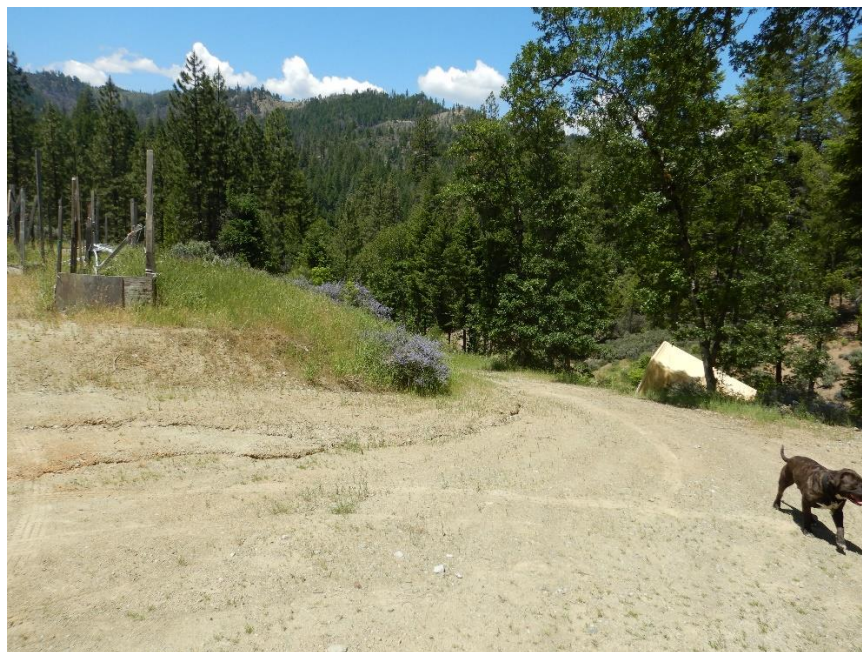
photo 14 – Road out sloped towards valley with rills running along the inside edge.

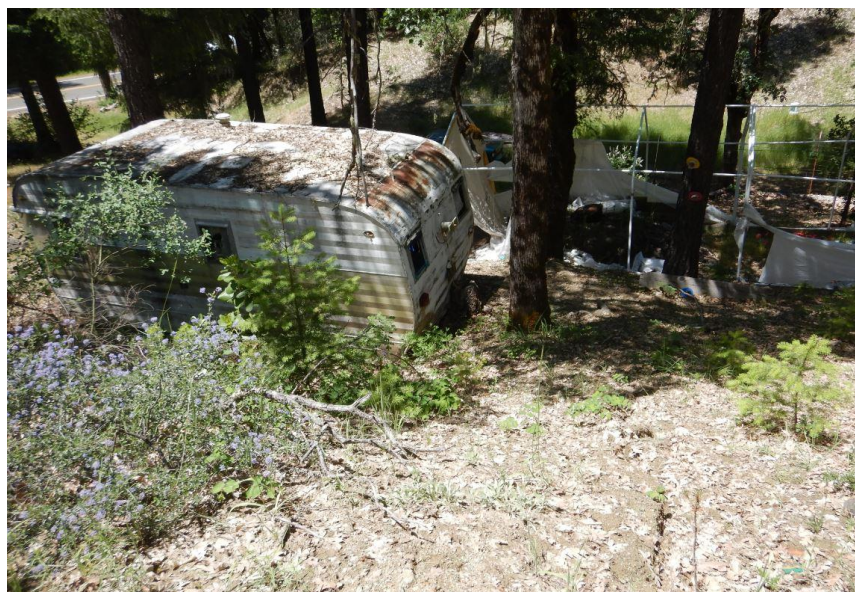
photo 15 – Trailer and frame of temporary building where potting soils from the valley were reported to have been placed. Note highway 3 in background of image and absence of cover on the temporary building.

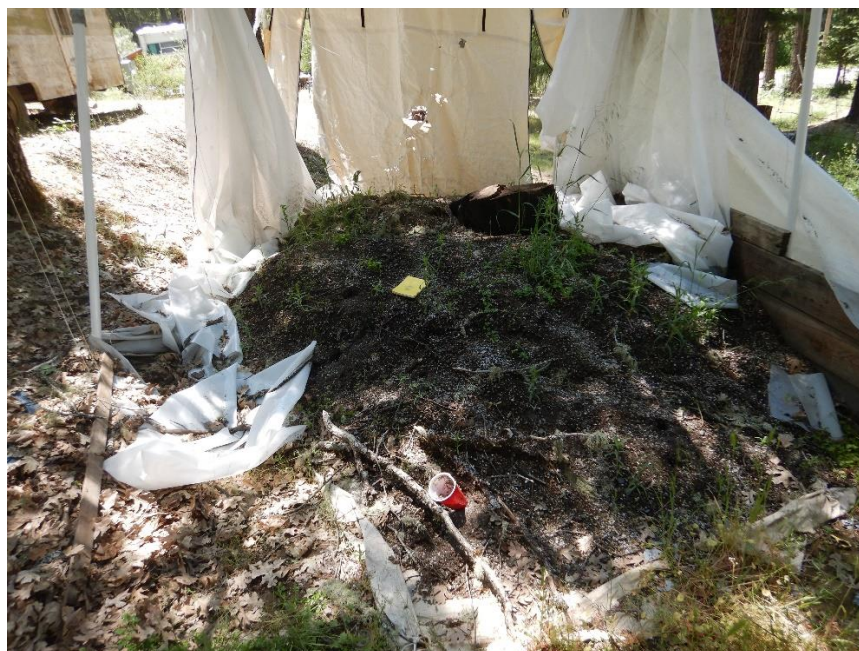
photo 16 – Pile of potting soils inside of temporary building pictured in photo 15.
